# Smoke and Dye Testing Summary

## High Level Sewershed

Test ID	Test Type	Date Inspected	Company / Super.	Blower MH	Ground Condition	Notification Made?	Total Length
S1028-219	Smoke	8/10/2009	ADS/TM	S19KK_045MH	Dry	Yes	403.72

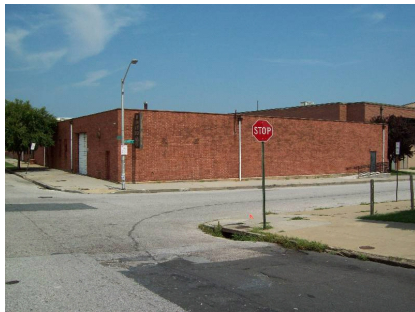
**Picture** \S1028-219-OB01-P01.jpg

**Comments** Smoke from catch basin along curb. 2029 Payson St.

**Comments** Payson St. & Clifton Ave. looking northeast

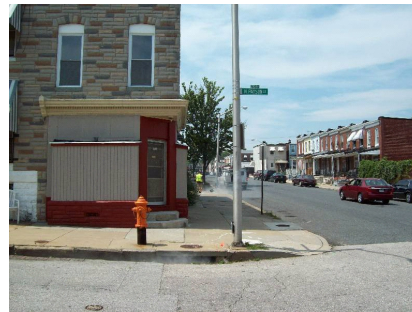
**Picture** \S1028-219-OB02-P01.jpg

**Comments** Smoke from catch basin along curb. 2028 Payson St.

**Comments** Payson St. & Clifton Ave. looking west

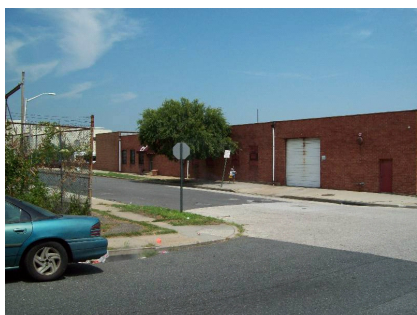
**Picture** \S1028-219-OB03-P01.jpg

**Comments** Smoke from catch basin along curb.  
Northwest corner of Payson St. & Clifton Ave.

**Comments** Payson St. & Clifton Ave. looking  
northeast
